## The Migration of an Intrauterine Device in the Bladder of an Asymptomatic Woman: A Case Report

### Abstract

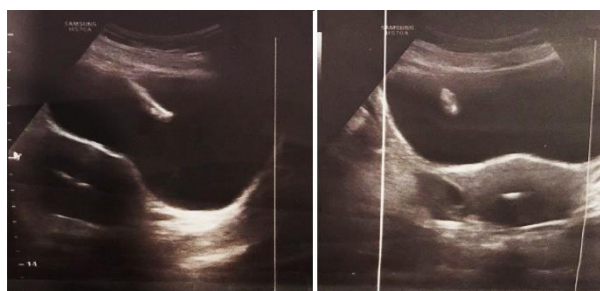
Eight years after the second IUD was placed (October 2022), the patient underwent a pelvic ultrasound following routine tests and the discovery of pyuria in the urine test. The findings of the patient's ultrasound are as follows; the ultrasound revealed an echogenic linear structure measuring 28 mm protruding from the anterior wall of the bladder into the lumen, suggestive of a foreign body or a bladder wall septum secondary to lobulation (Figure 1).

**Figure 1.** Ultrasound image showing IUD in uterus and bladder

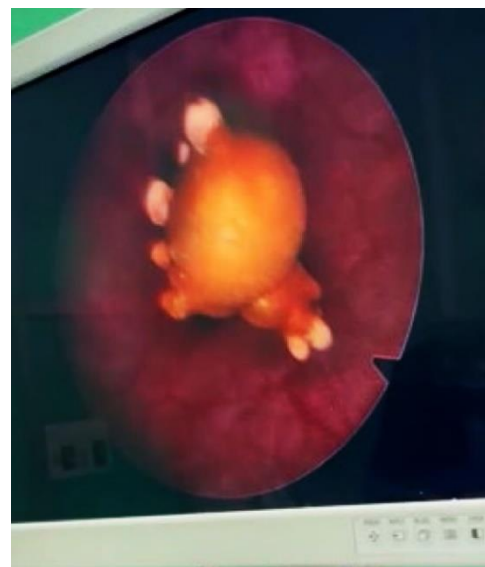
Cystoscopy was performed at Imam Reza University Hospital under general anesthesia using the Olympus system with a 2.9 mm lens and a 30 degree angle. The IUD was observed adhering to the bladder wall, with a stone deposit visible on it. The IUD was easily removed with a cystoscope grasper. No evidence of fistula or additional stones was found on the repeat cystoscopy (Figure 3).

**Figure 3.** Cystoscopic view of the migrated intrauterine device (IUD)
