The Migration of an Intrauterine Device in the Bladder of an Asymptomatic Woman: A Case Report

To cite this article: Pourhoseini SA, Hafizi L, Jafari M. The Migration of an Intrauterine Device in the Bladder of an Asymptomatic Woman: A Case Report. *J Reprod Infertil.* 2024; 25(3):238-241. <https://doi.org/10.18502/jri.v25i3.17019>.

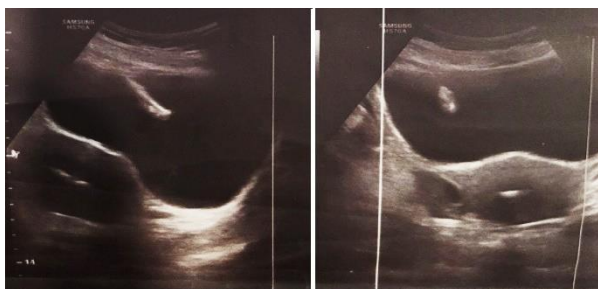
Figure 1. Ultrasound image showing IUD in uterus and bladder

Eight years after the second IUD was placed (October 2022), the patient underwent a pelvic ultrasound following routine tests and the discovery of pyuria in the urine test. The findings of the patient's ultrasound are as follows; the ultrasound revealed an echogenic linear structure measuring 28 mm protruding from the anterior wall of the bladder into the lumen, suggestive of a foreign body or a bladder wall septum secondary to lobulation (Figure 1).

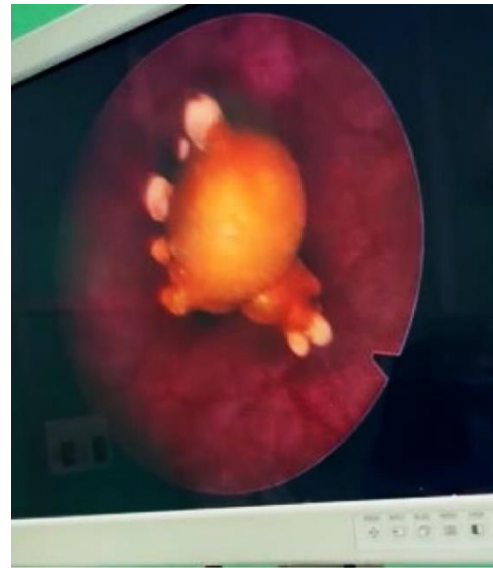
Figure 3. Cystoscopic view of the migrated intrauterine device (IUD)

Cystoscopy was performed at Imam Reza University Hospital under general anesthesia using the Olympus system with a 2.9 mm lens and a 30 degree angle. The IUD was observed adhering to the bladder wall, with a stone deposit visible on it. The IUD was easily removed with a cystoscope grasper. No evidence of fistula or additional stones was found on the repeat cystoscopy (Figure 3).
